Appraisal-Level Investigation Summary of Findings

Verde River Fish Barrier Central Arizona Project

U.S. Department of the Interior
Bureau of Reclamation
Phoenix Area Office
June 2010

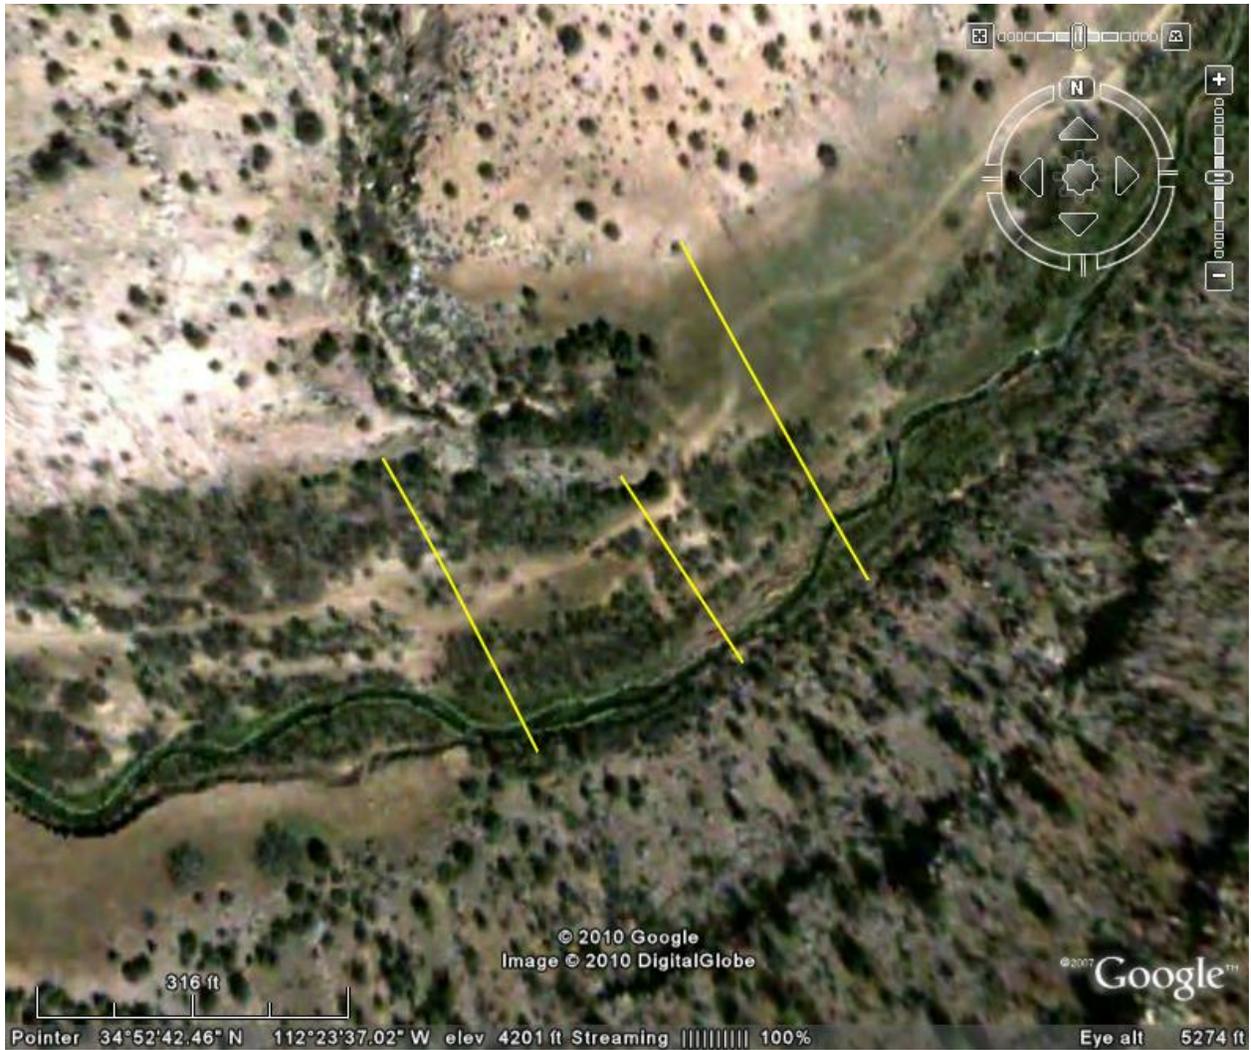
Photo 1 – Aerial view of the three AZGFD sites. River flows from left to right. The furthest downstream alignment is Site A, the upper alignment is Site B, and the middle line depicts Site C.

Three potential fish barrier sites were identified within a 500-foot reach of the river near the downstream boundary of AZGFD land. This part of the river is the only portion of AZGFD property where the canyon walls narrow to less than 400 feet. Site A is located within 100 feet of the fence marking the boundary of the AZGFD property (Photo 2). The fish barrier would be about 370 feet across with rock at each end to tie to.

Site B is located about 400 feet upstream of the boundary fence. The canyon walls narrow to 330 feet, and provide rock at each abutment. Site B is the preferred location of the three AZGFD sites, and the cost estimate is based on this site.

Site C, located 190 feet upstream of the boundary fence, is actually the narrowest at 225 feet. The right end ties into rock at the right abutment. However, the left end of the structure at Site C would tie into a 250-foot long manmade rock and earthfill dike. The dike appears to have been placed to redirect a side drainage that comes in from the north. Although Site C is narrower than the others, the potential exists for the dike to fail by overtopping considering the higher water surface resulting from a fish barrier. Without analyses of the river hydraulics and the dike

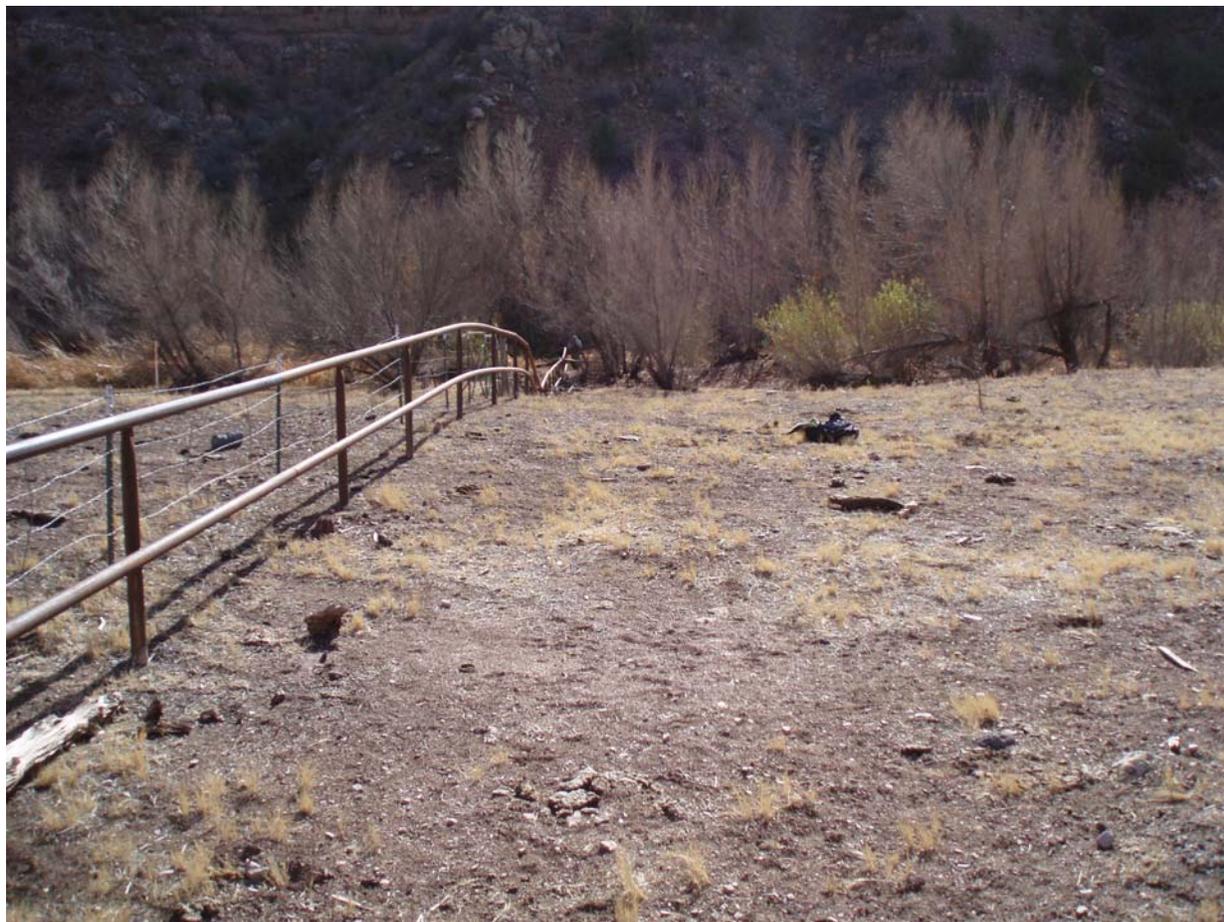
Photo 2 – AZGFD Site A. Barrier would be located upstream (right) of the cattle control fencing. This view is from near the left canyon wall. The river is obscured by the cottonwood trees.

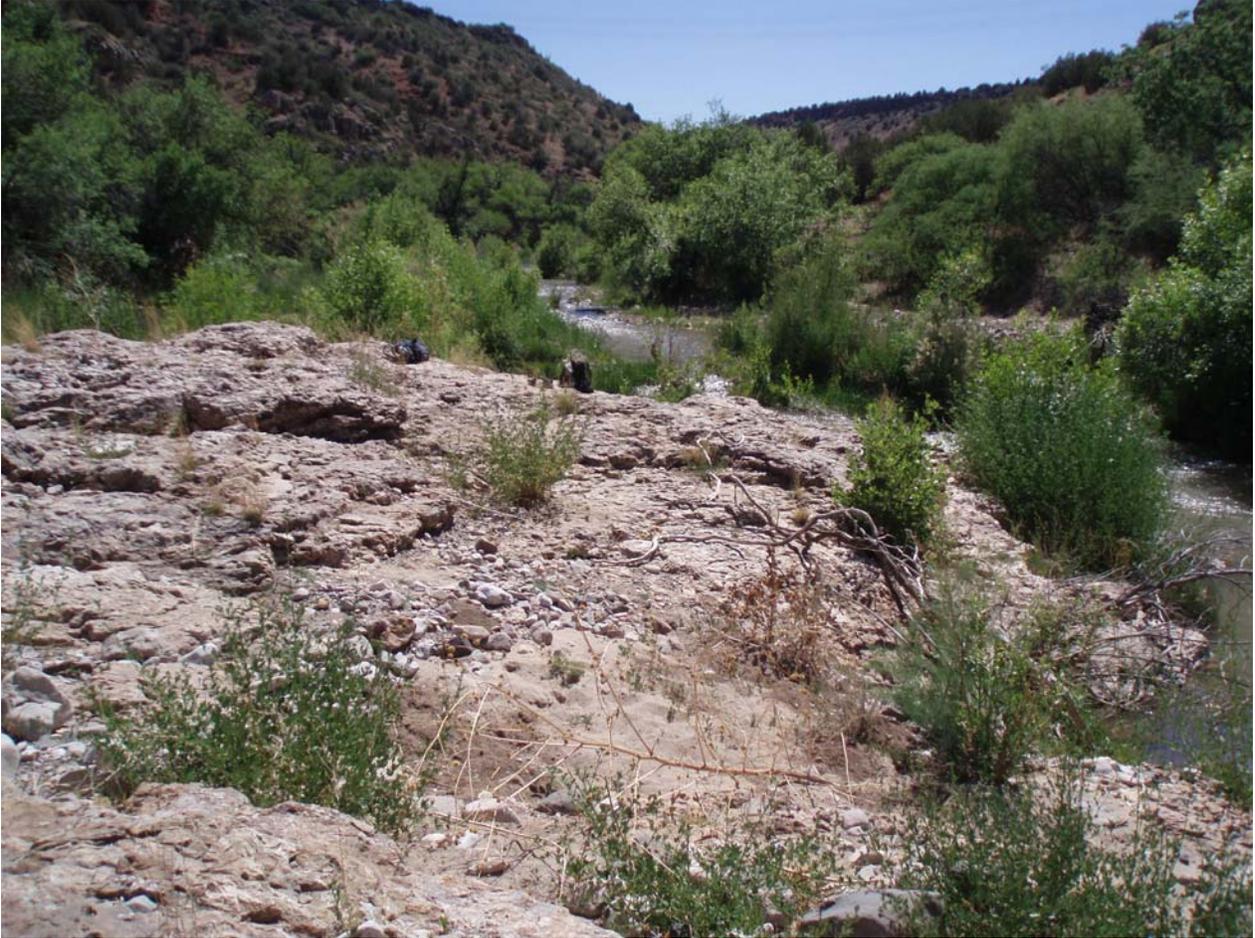
Photo 3 - Site 1 (Hell Point) looking upstream.

Located 0.4 miles upstream of the confluence with Hell Canyon in Prescott National Forest, this site is about 185 feet wide, and offers a bedrock outcrop that extends halfway across the channel (Photos 3-5). A barrier at this site would protect approximately 16.7 miles of perennial river for native fishes. Existing dirt roads in moderate condition provide access to the top of the 350-foot deep canyon. Three jeep trails drop into the canyon at the confluence 0.4 miles from the fish barrier site. Two of the roads come from the north on each side of Hell Canyon. Another arrives from the south side of the Verde River.

The bedrock intrusion slopes down from the right canyon wall and dives below the alluvium about halfway across the canyon. The remainder of the stream channel to the vertical rock face on the left abutment is alluvium.

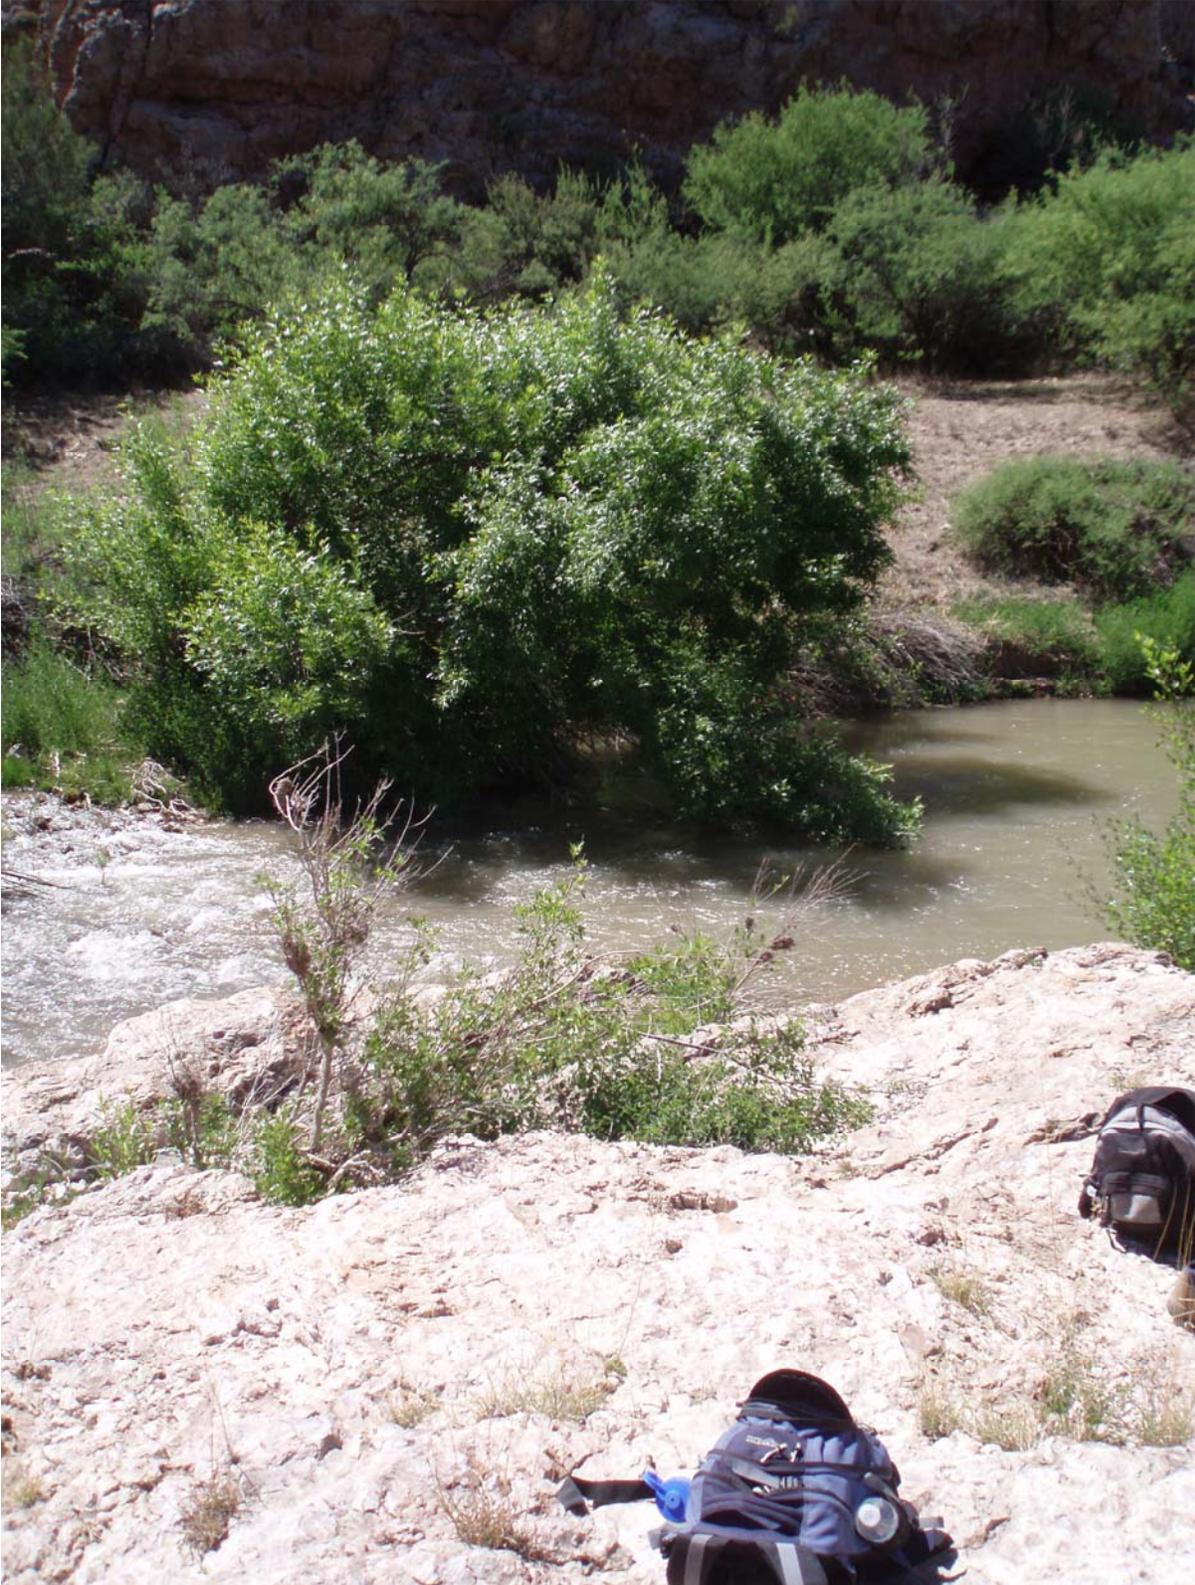
Photo 4 - Site 1 (Hell Point) looking across river toward left abutment.

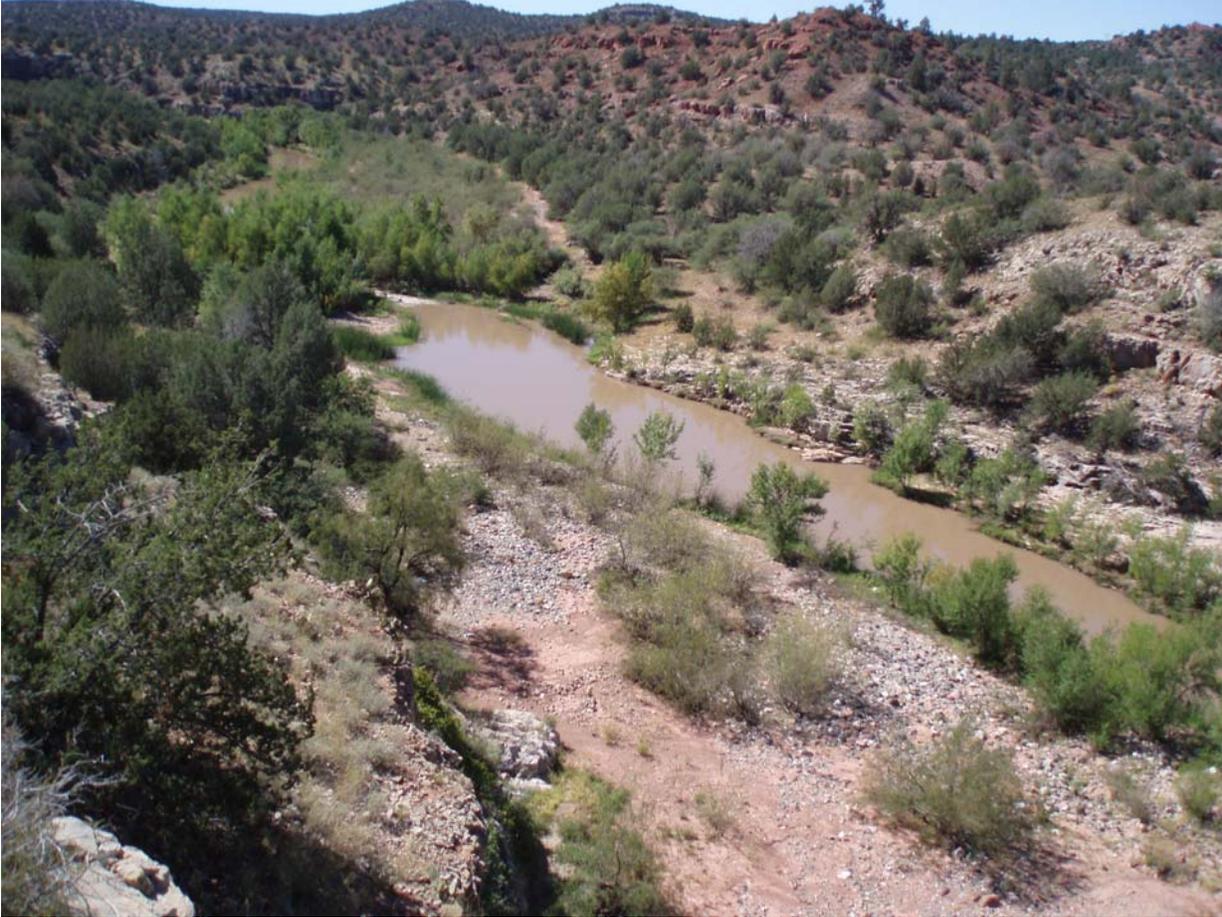
Photo 6 – Site 2, U.S. Mine (Bear Siding) – Looking downstream from top of canyon at location of downstream site.

There are two viable locations for fish barriers, about 200 feet apart from each other. The upstream site is 181 feet across, and the downstream site is 165 feet across. Each has rock canyon walls to tie into, with alluvium foundation between.

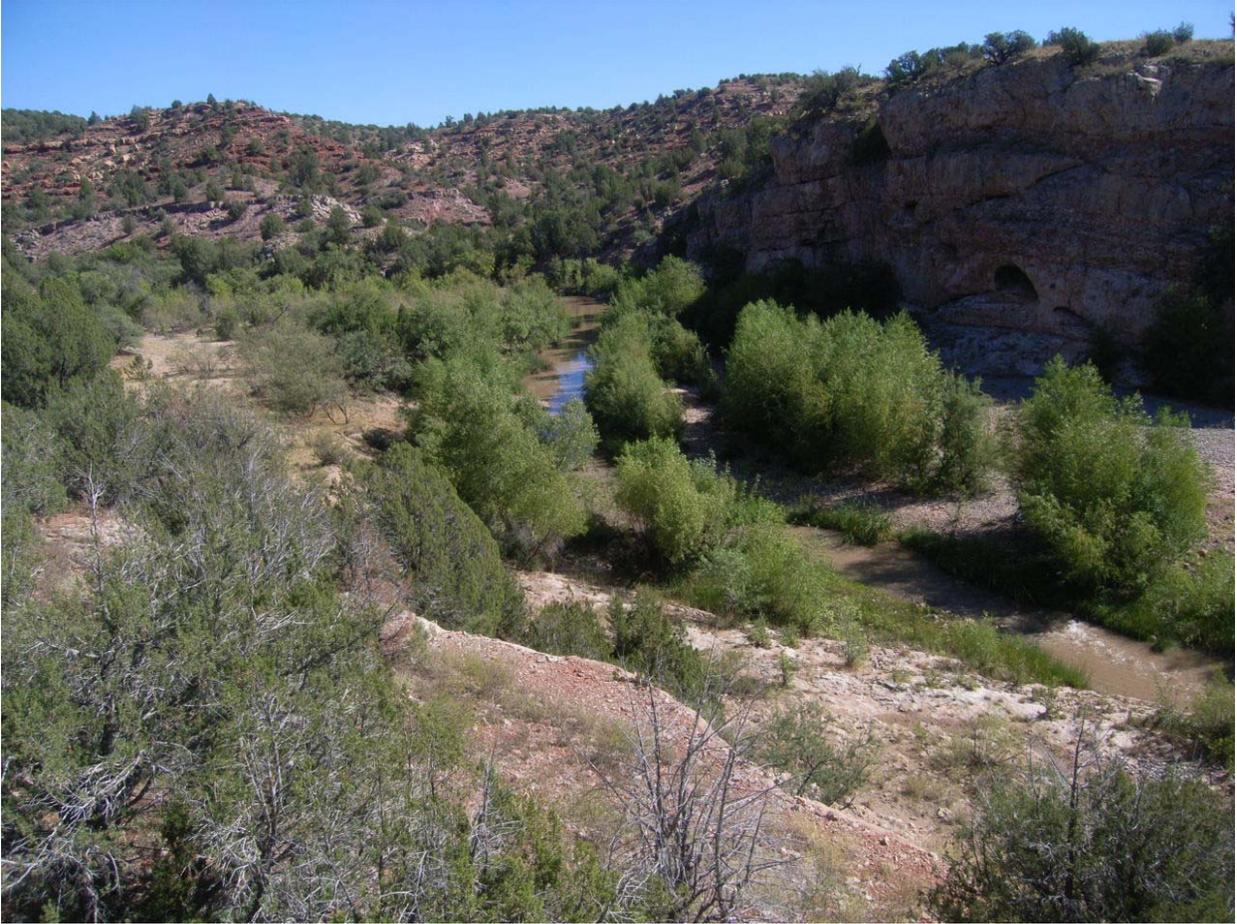
Photo 7 - Site 2, U.S. Mine (Bear Siding) – Looking upstream at location of upstream site.

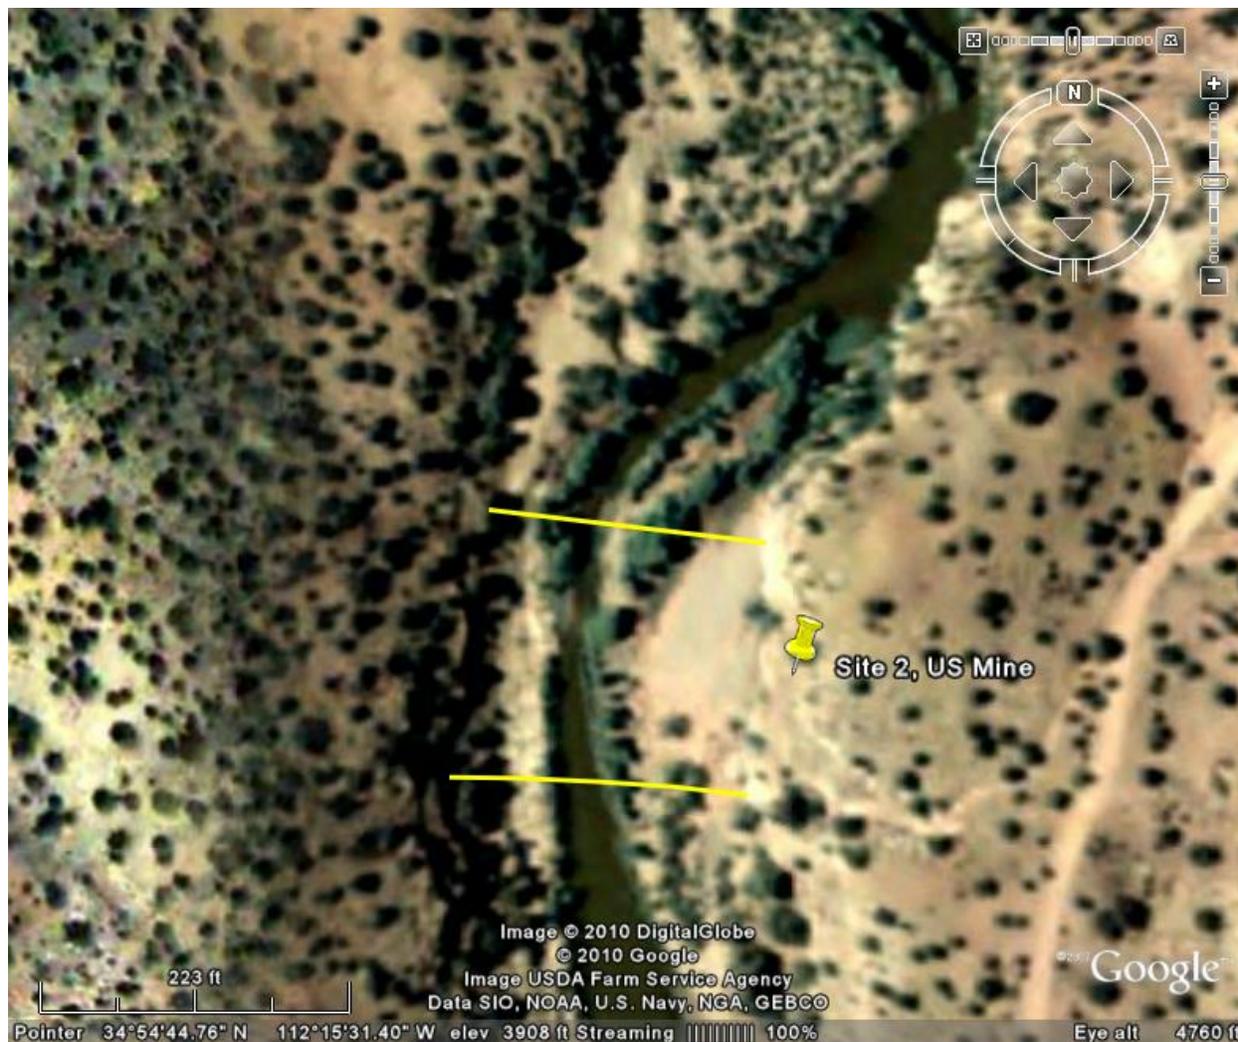
Photo 8 - Site 2, U.S. Mine (Bear Siding) – Plan view of the two sites, river flowing down the page. Note the canyon-top road at right.

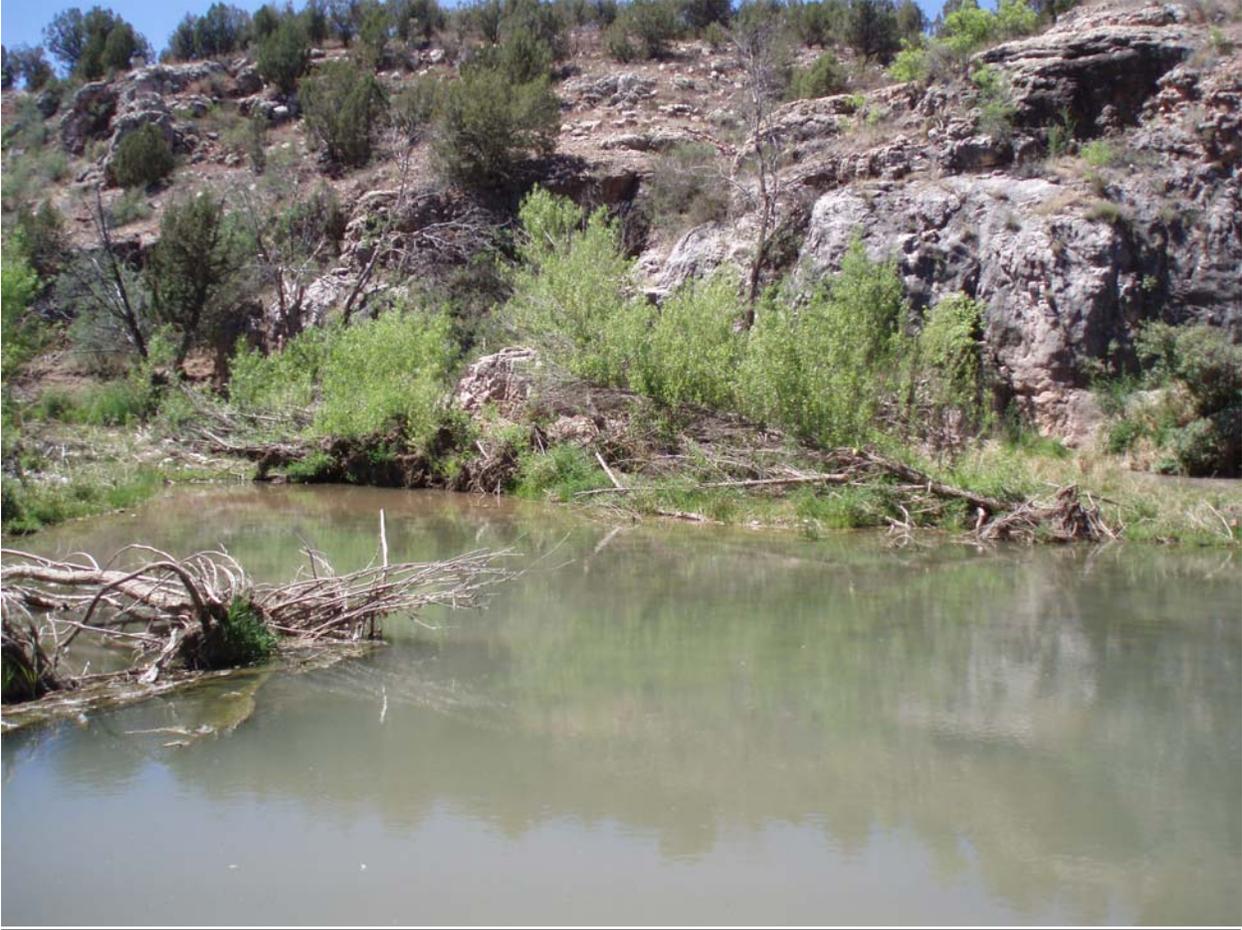
Photo 9 - Site 3, Perkinsville – Looking across river at right abutment rock.

The fish barrier site is located on a slow moving stretch of the river. Rock canyon walls are about 140 feet apart with a 20-foot wide terrace on the left abutment.

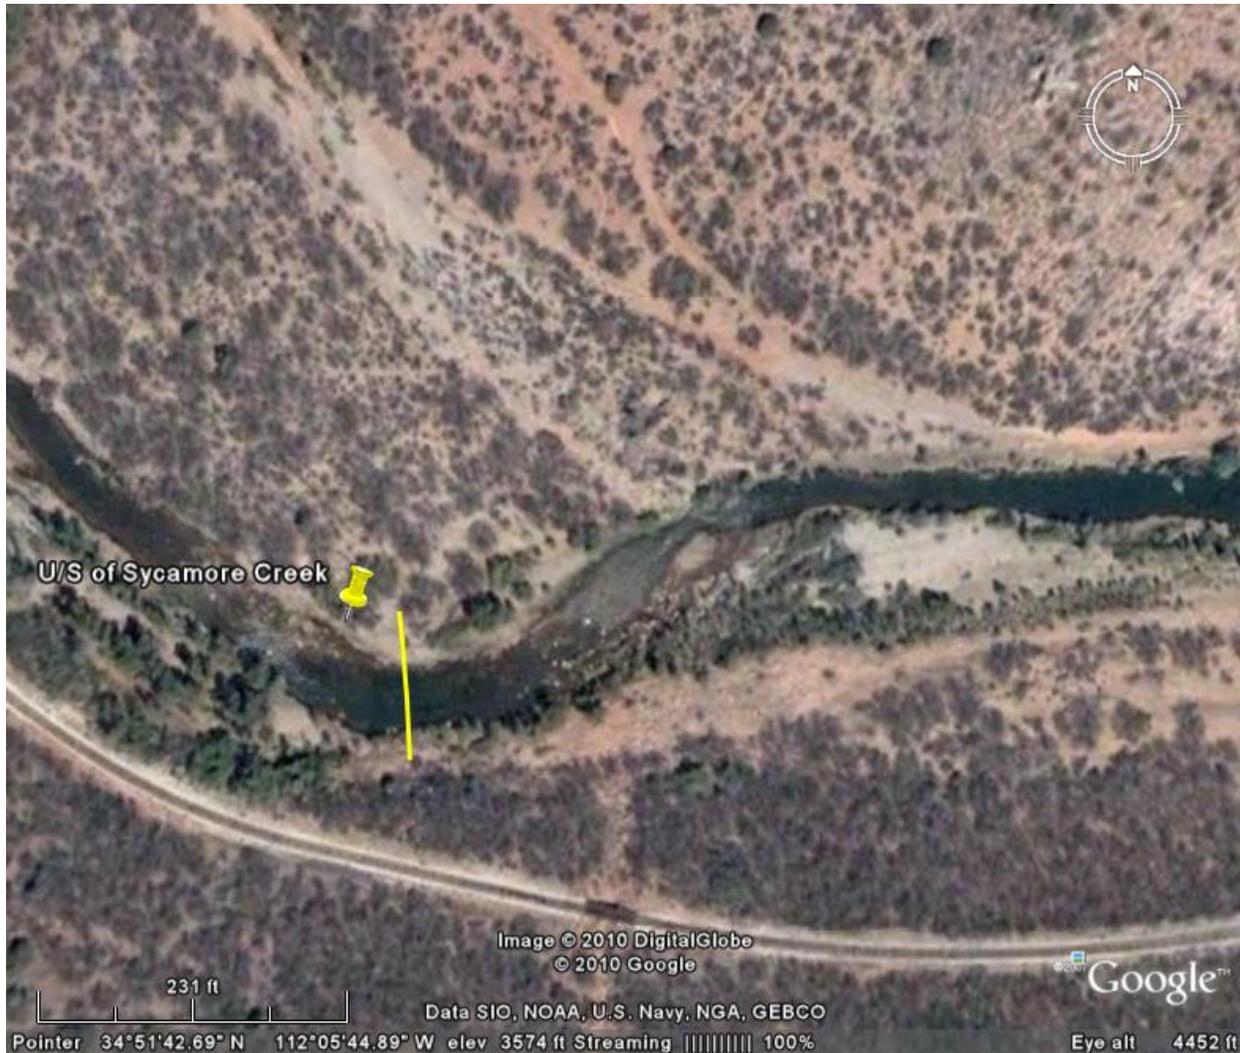
Photo 11 - Site 9, 1.1 miles upstream of Sycamore Canyon – Plan view, river flowing from left to right. The access road enters the photo from the right, above the river. The train tracks are at the bottom of the photo.

This site was discovered during review of aerial images and has not undergone on-site evaluation (Photo 11). A barrier at this site would protect approximately 34.7 miles of perennial river for native fishes. There appears to be private holdings along the road, which runs from Sycamore Canyon along the river to the site. The road appears from aerial images to be passable, and provides access to within 500 feet of the barrier site at river level. The river would need to be forded twice to reach the site.

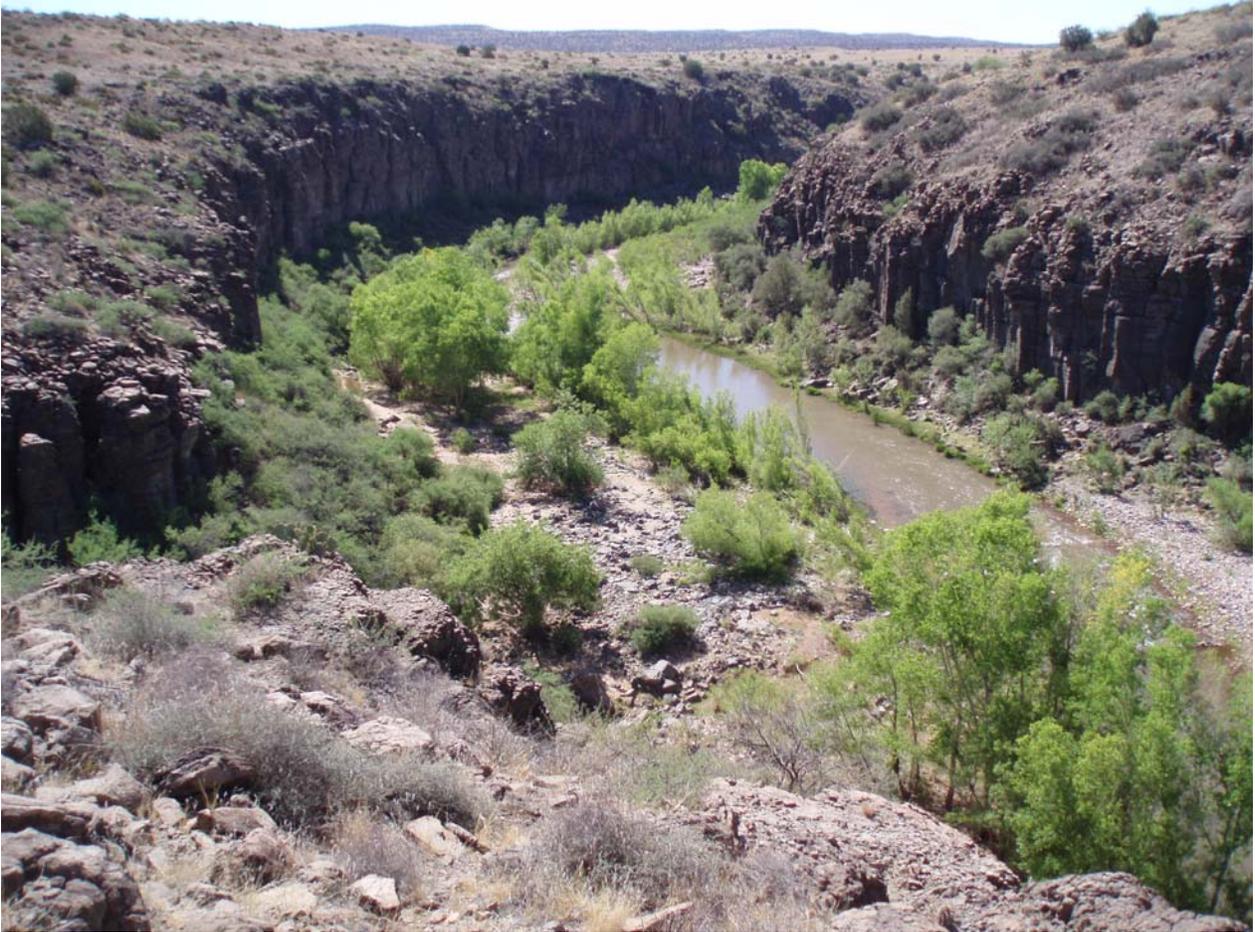
Photo 12 – Site 6 – Looking downstream. Sites 4 and 5 similar.

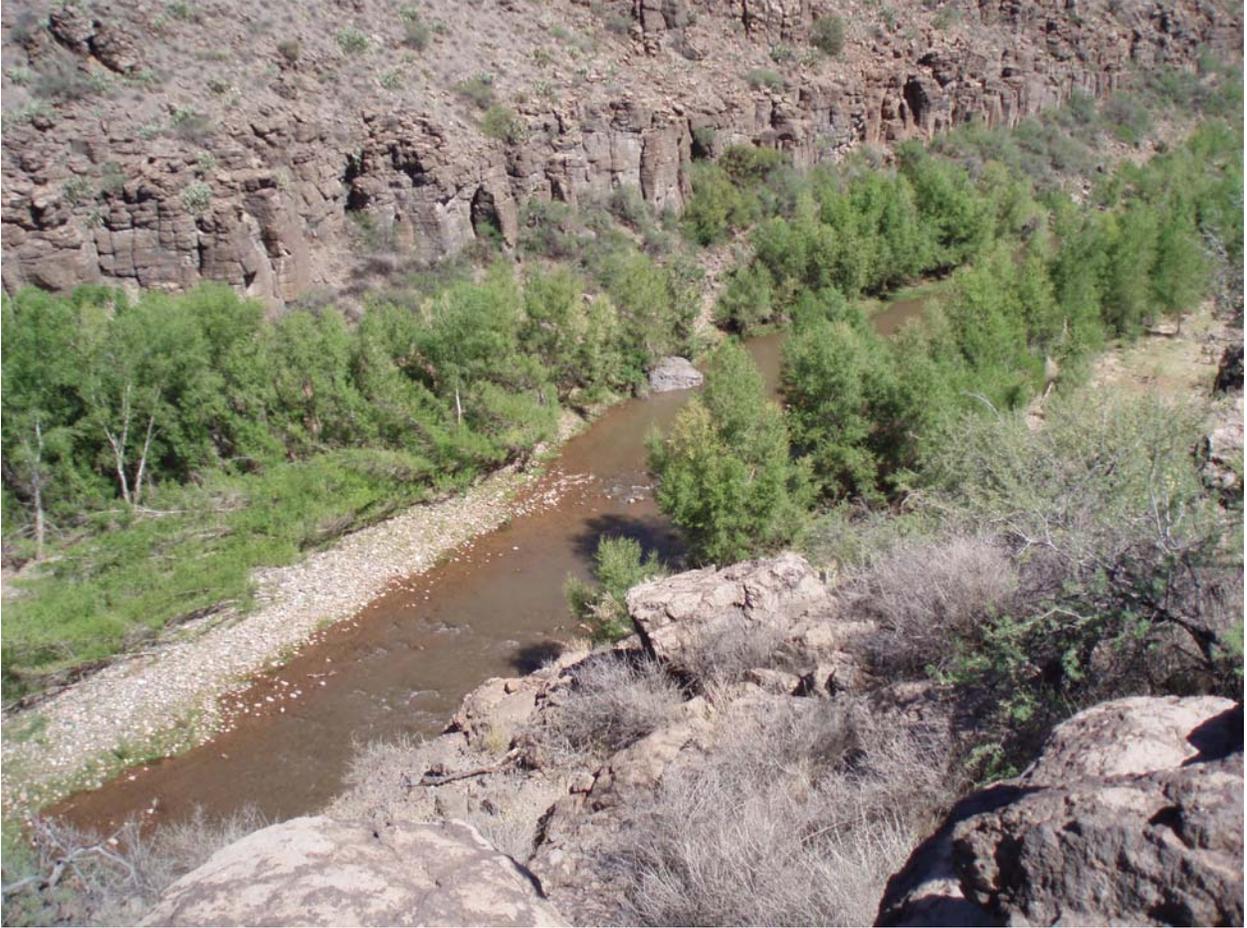
Photo 14 – Site 7 – Looking upstream from east side of canyon.

This site has similar characteristics as Sites 4, 5, and 6 and is reached by driving approximately 7 miles north of Clarkdale (Photos 14-15). A barrier at this site would protect approximately 41.5 miles of perennial river for native fishes. This part of the river has good access via gravel road from Clarkdale. The last mile to the top of the canyon is dirt, but in good condition. The canyon walls are 100 feet above the river. The canyon walls are extremely steep, making the possibility of pioneering a road down to the river virtually impossible. An alternate construction access method would be to construct a cableway system from the top of the canyon to bring in materials, supplies, equipment, and possibly personnel.

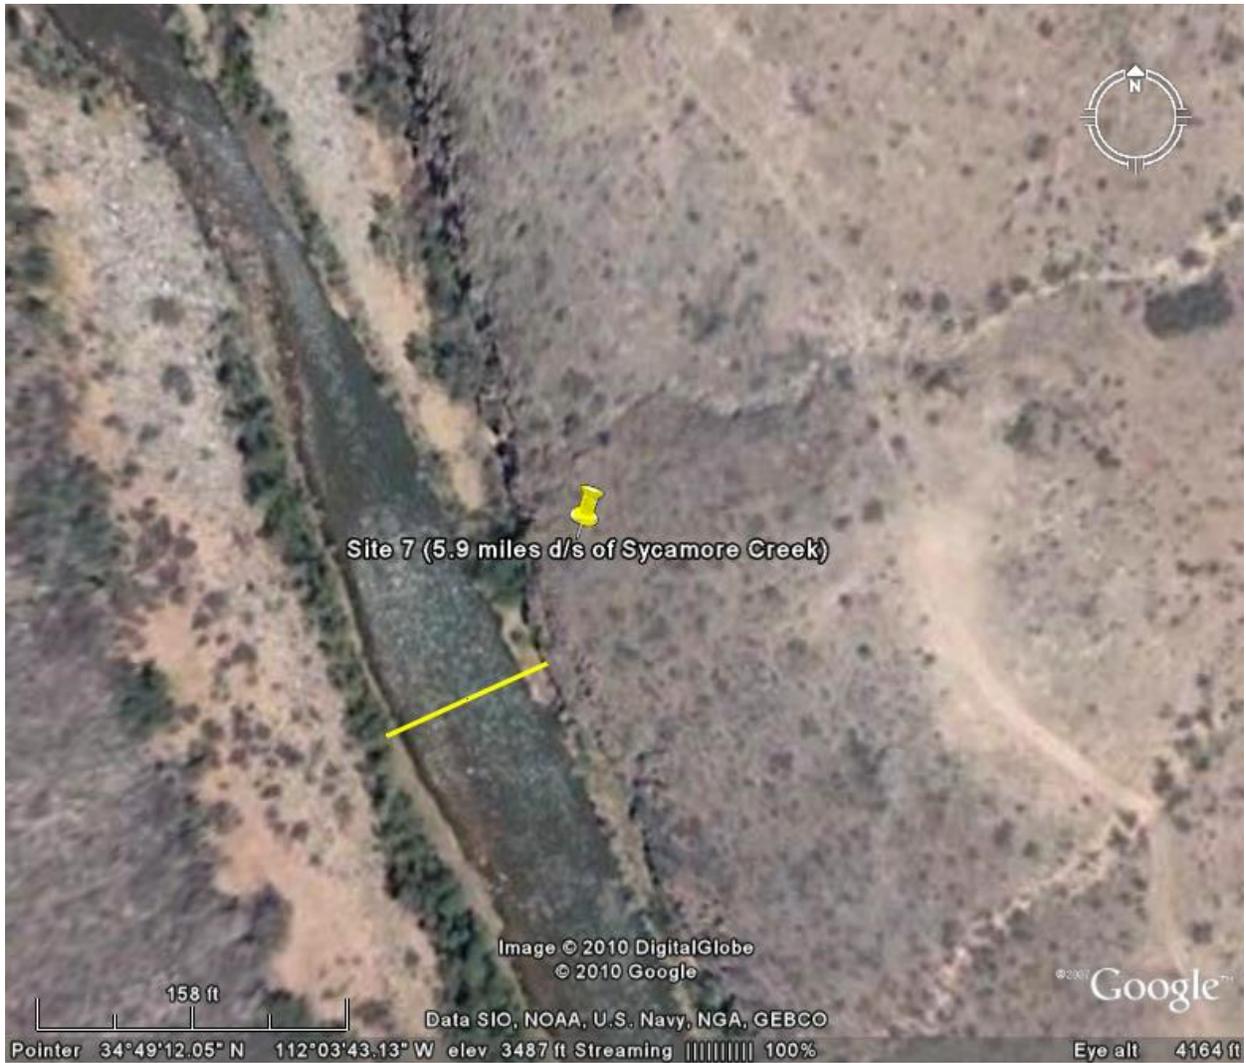
Photo 15 – Site 7 – Plan view. River is flowing down the page.

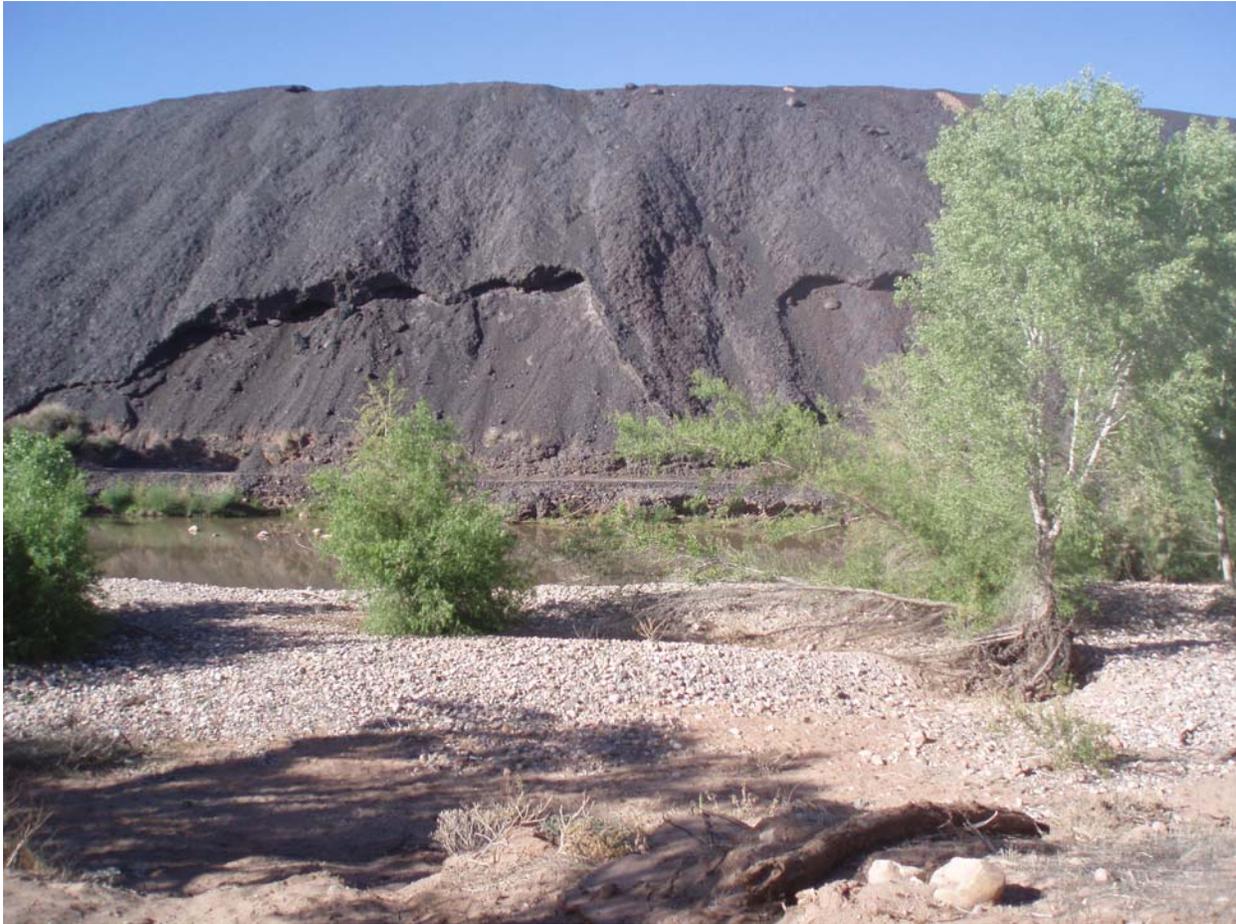
Photo 16 – Site 8 – Looking southwest from road. Verde River is in center of photo. Tailings mound is about 100 feet in height.

The riverside slope of the mill tailings pile is at or steeper than the angle of repose. Photo 16 shows that the slopes have slid in the past, probably due to river flows against the pile, leaving overhanging sections. This unstable condition would need to be dealt with during construction to mitigate safety concerns. The barrier would need to key well into the pile to ensure river flows do not erode around the end of the barrier. This could entail removal of a significant amount of tailings materials since the slope is steep and the pile is about 100 feet tall. It may be preferable to treat or plate the surface of the pile with concrete to protect the tailings from river erosion and provide a hard, non-erodible surface to tie to. Or a jack-and-bore method could be used to install a concrete filled pipe into the tailings for the barrier to tie into. The other end of the barrier would tie into sedimentary geology on the other side of the road.

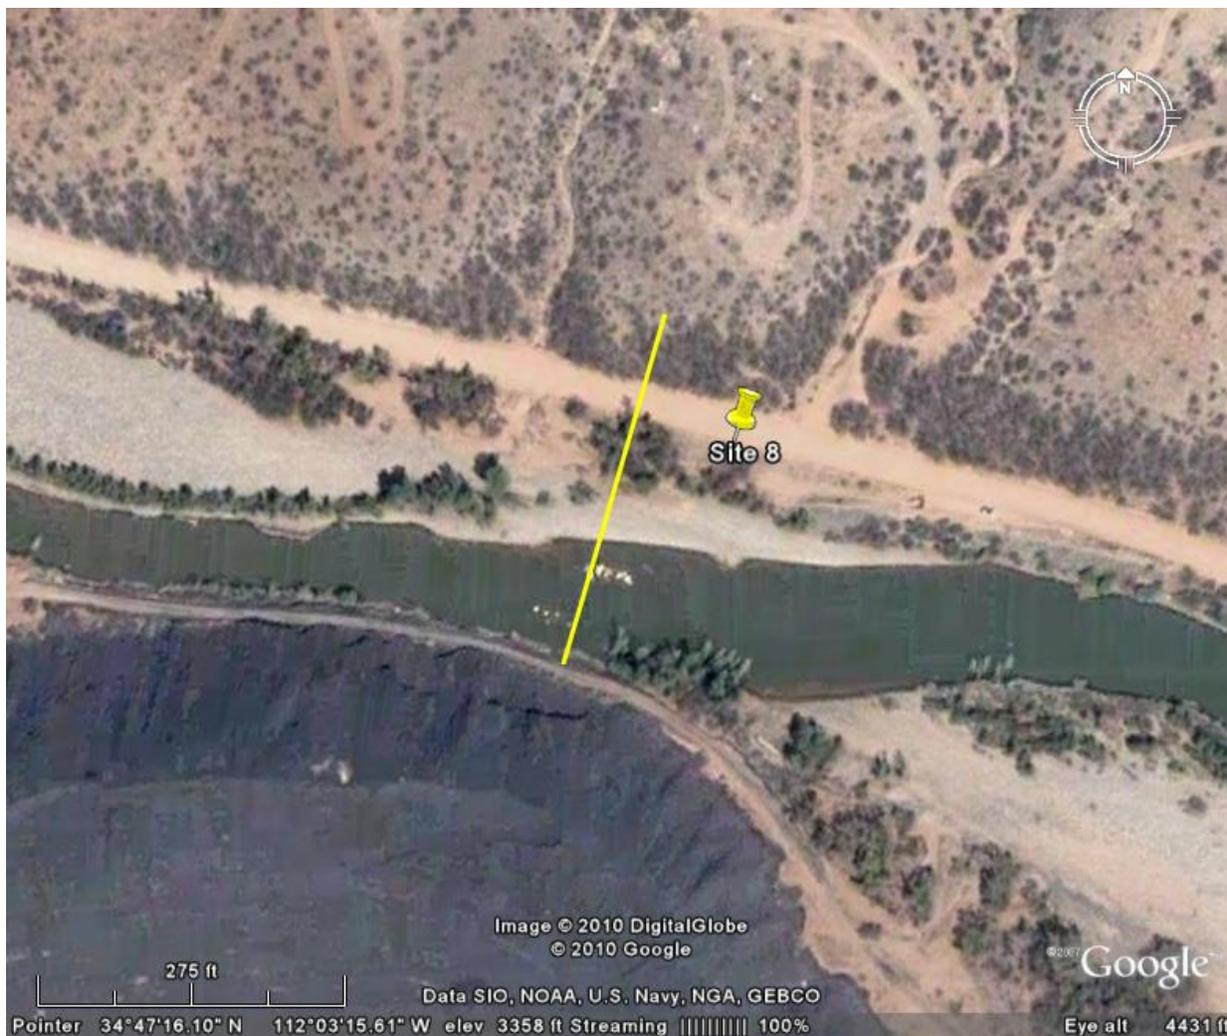
Photo 17 – Site 8 – Plan view. Tailings mound is at the lower left. The river is flowing from left to right.
